**EARTHQUAKE COMMISSION  
CHRISTCHURCH CITY & KAIAPOI**

Liquefaction and Lateral Spreading Observations  
Post February 2011

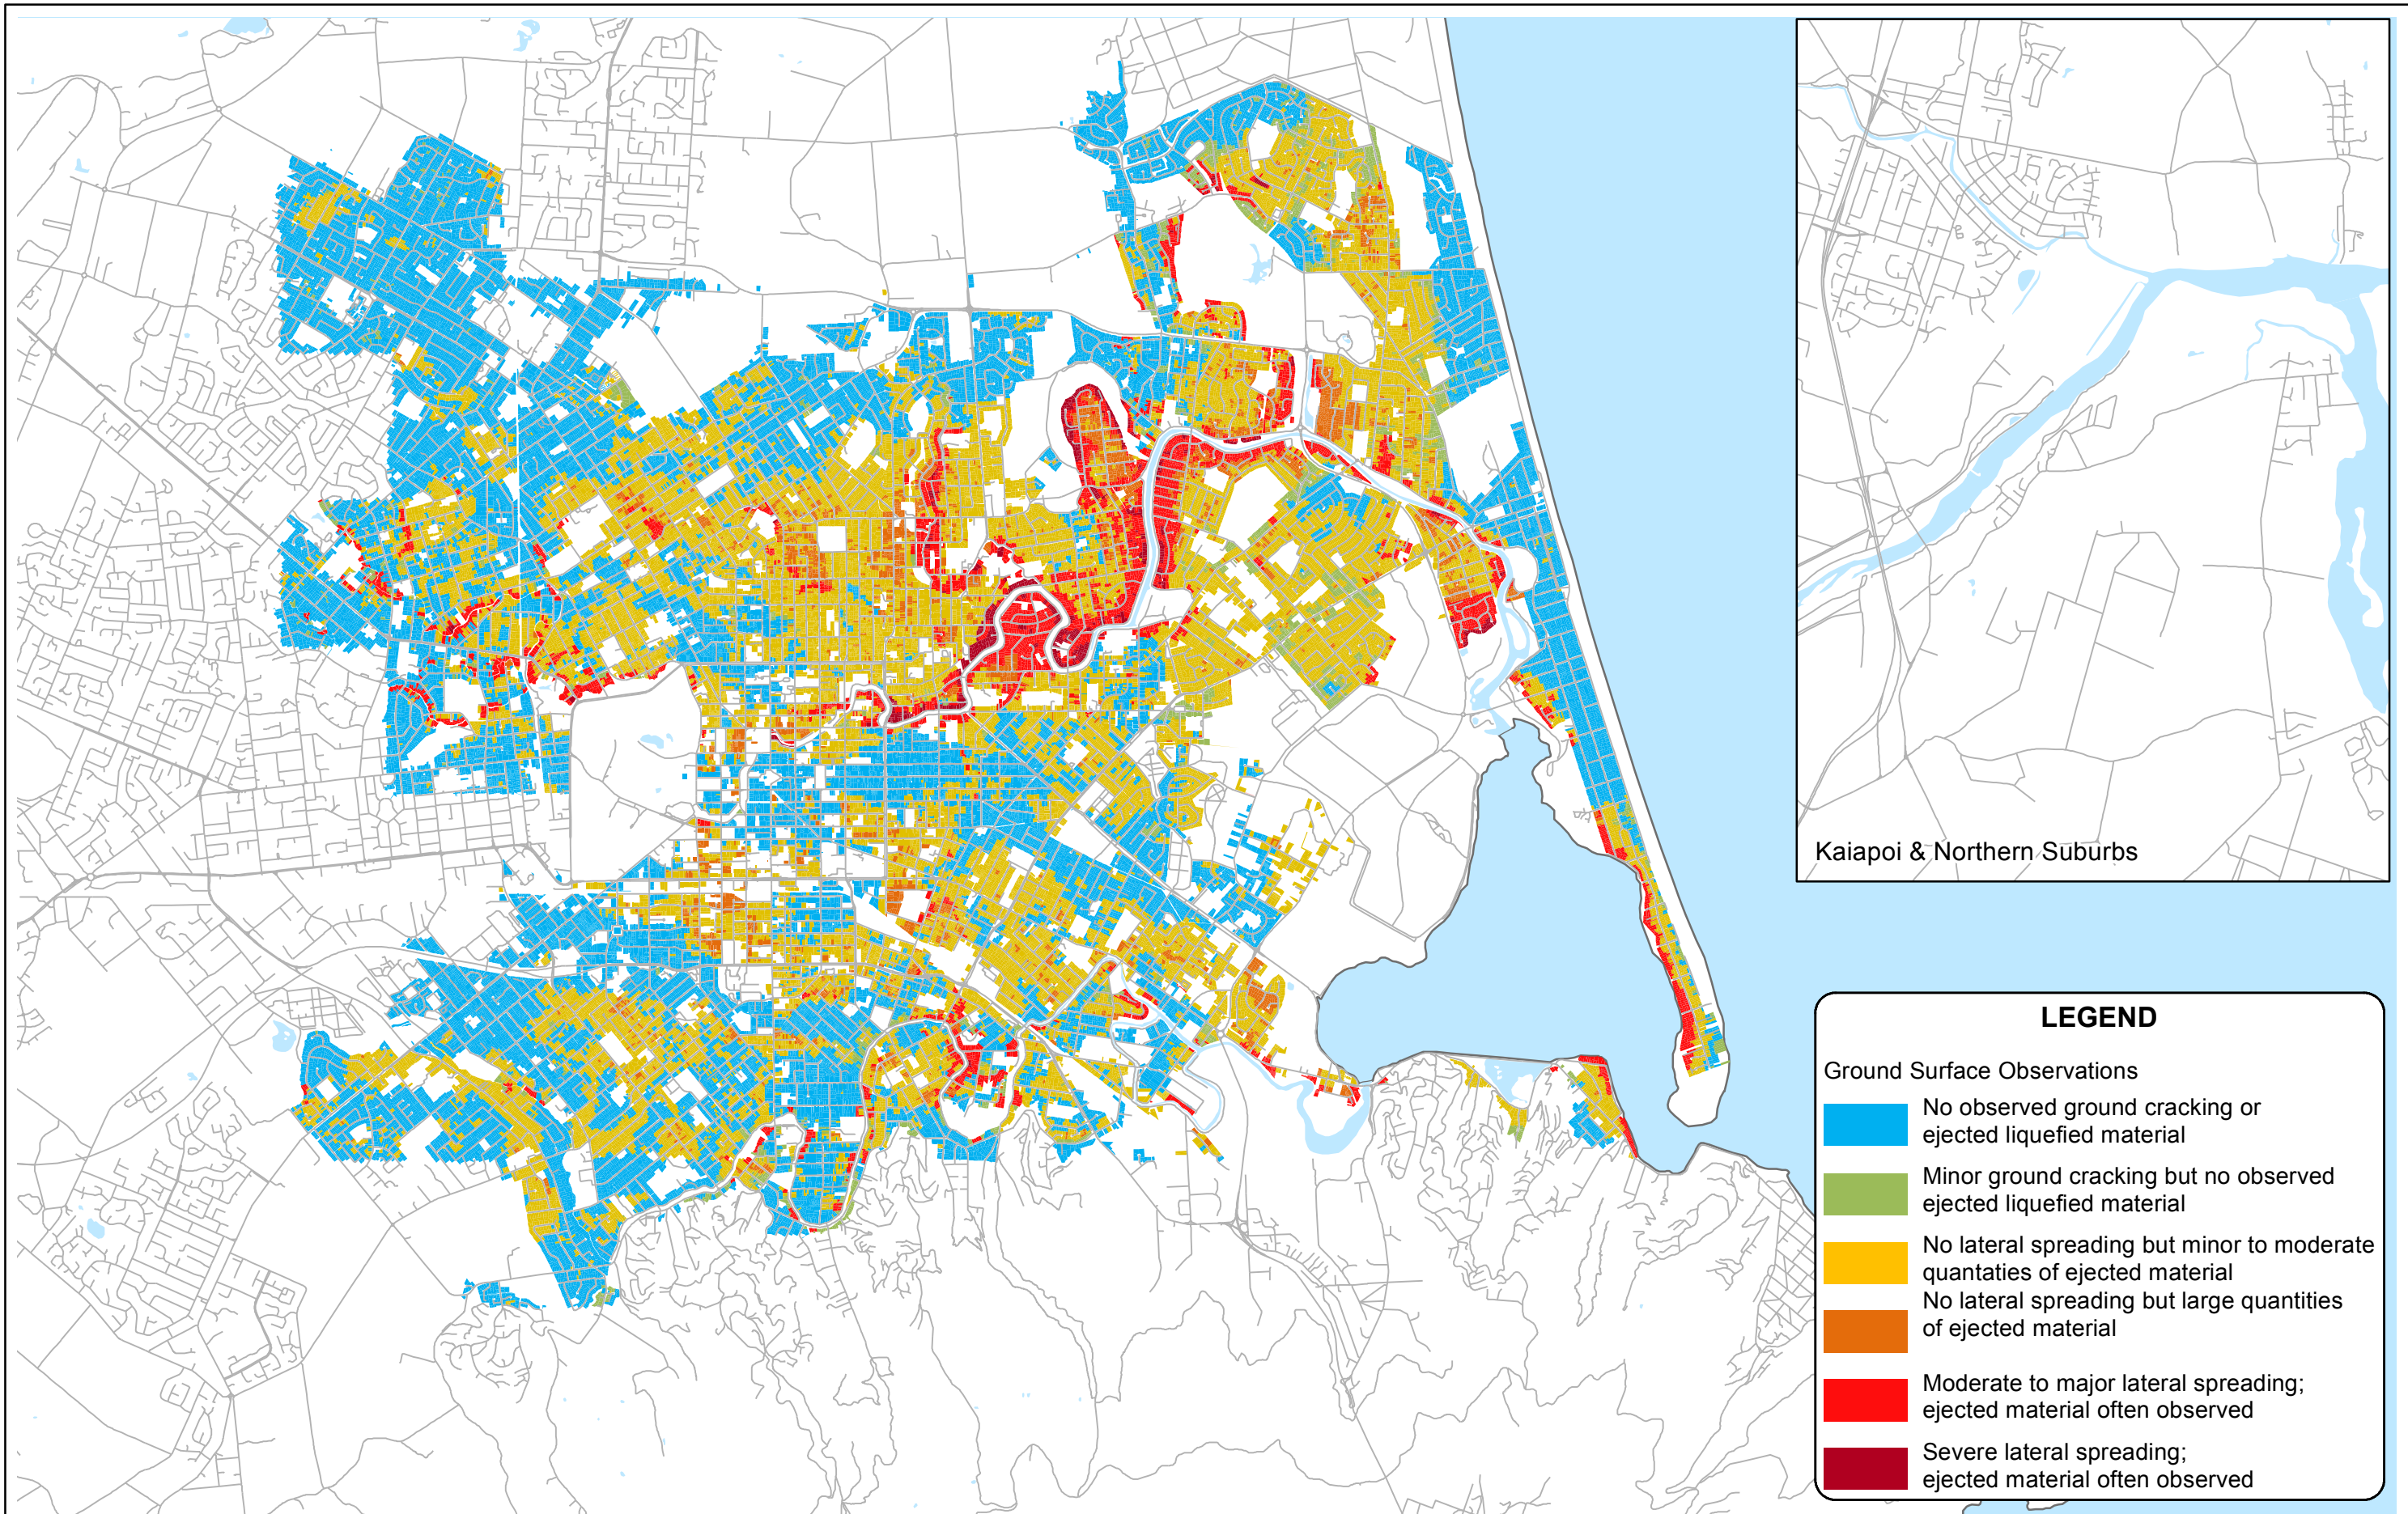
FIGURE No. \_\_\_\_\_

Ground Surface Observations

- No observed ground cracking or ejected liquefied material
- Minor ground cracking but no observed ejected liquefied material
- No lateral spreading but minor to moderate quantities of ejected material
- No lateral spreading but large quantities of ejected material
- Moderate to major lateral spreading; ejected material often observed
- Severe lateral spreading; ejected material often observed
