DRAWN	CXP	Feb.13
CHECKED		
APPROVED		
ARCFILE 52020-0200-LSN176		
SCALE (AT A3 SIZE) 1:60,000		
Prepared by Tonkin & Taylor Ltd Ref: 52020.0200

EARTHQUAKE COMMISSION
CHRISTCHURCH CITY & KAIAPOI
 LSN, April 2011
 (Using UoC PGA)

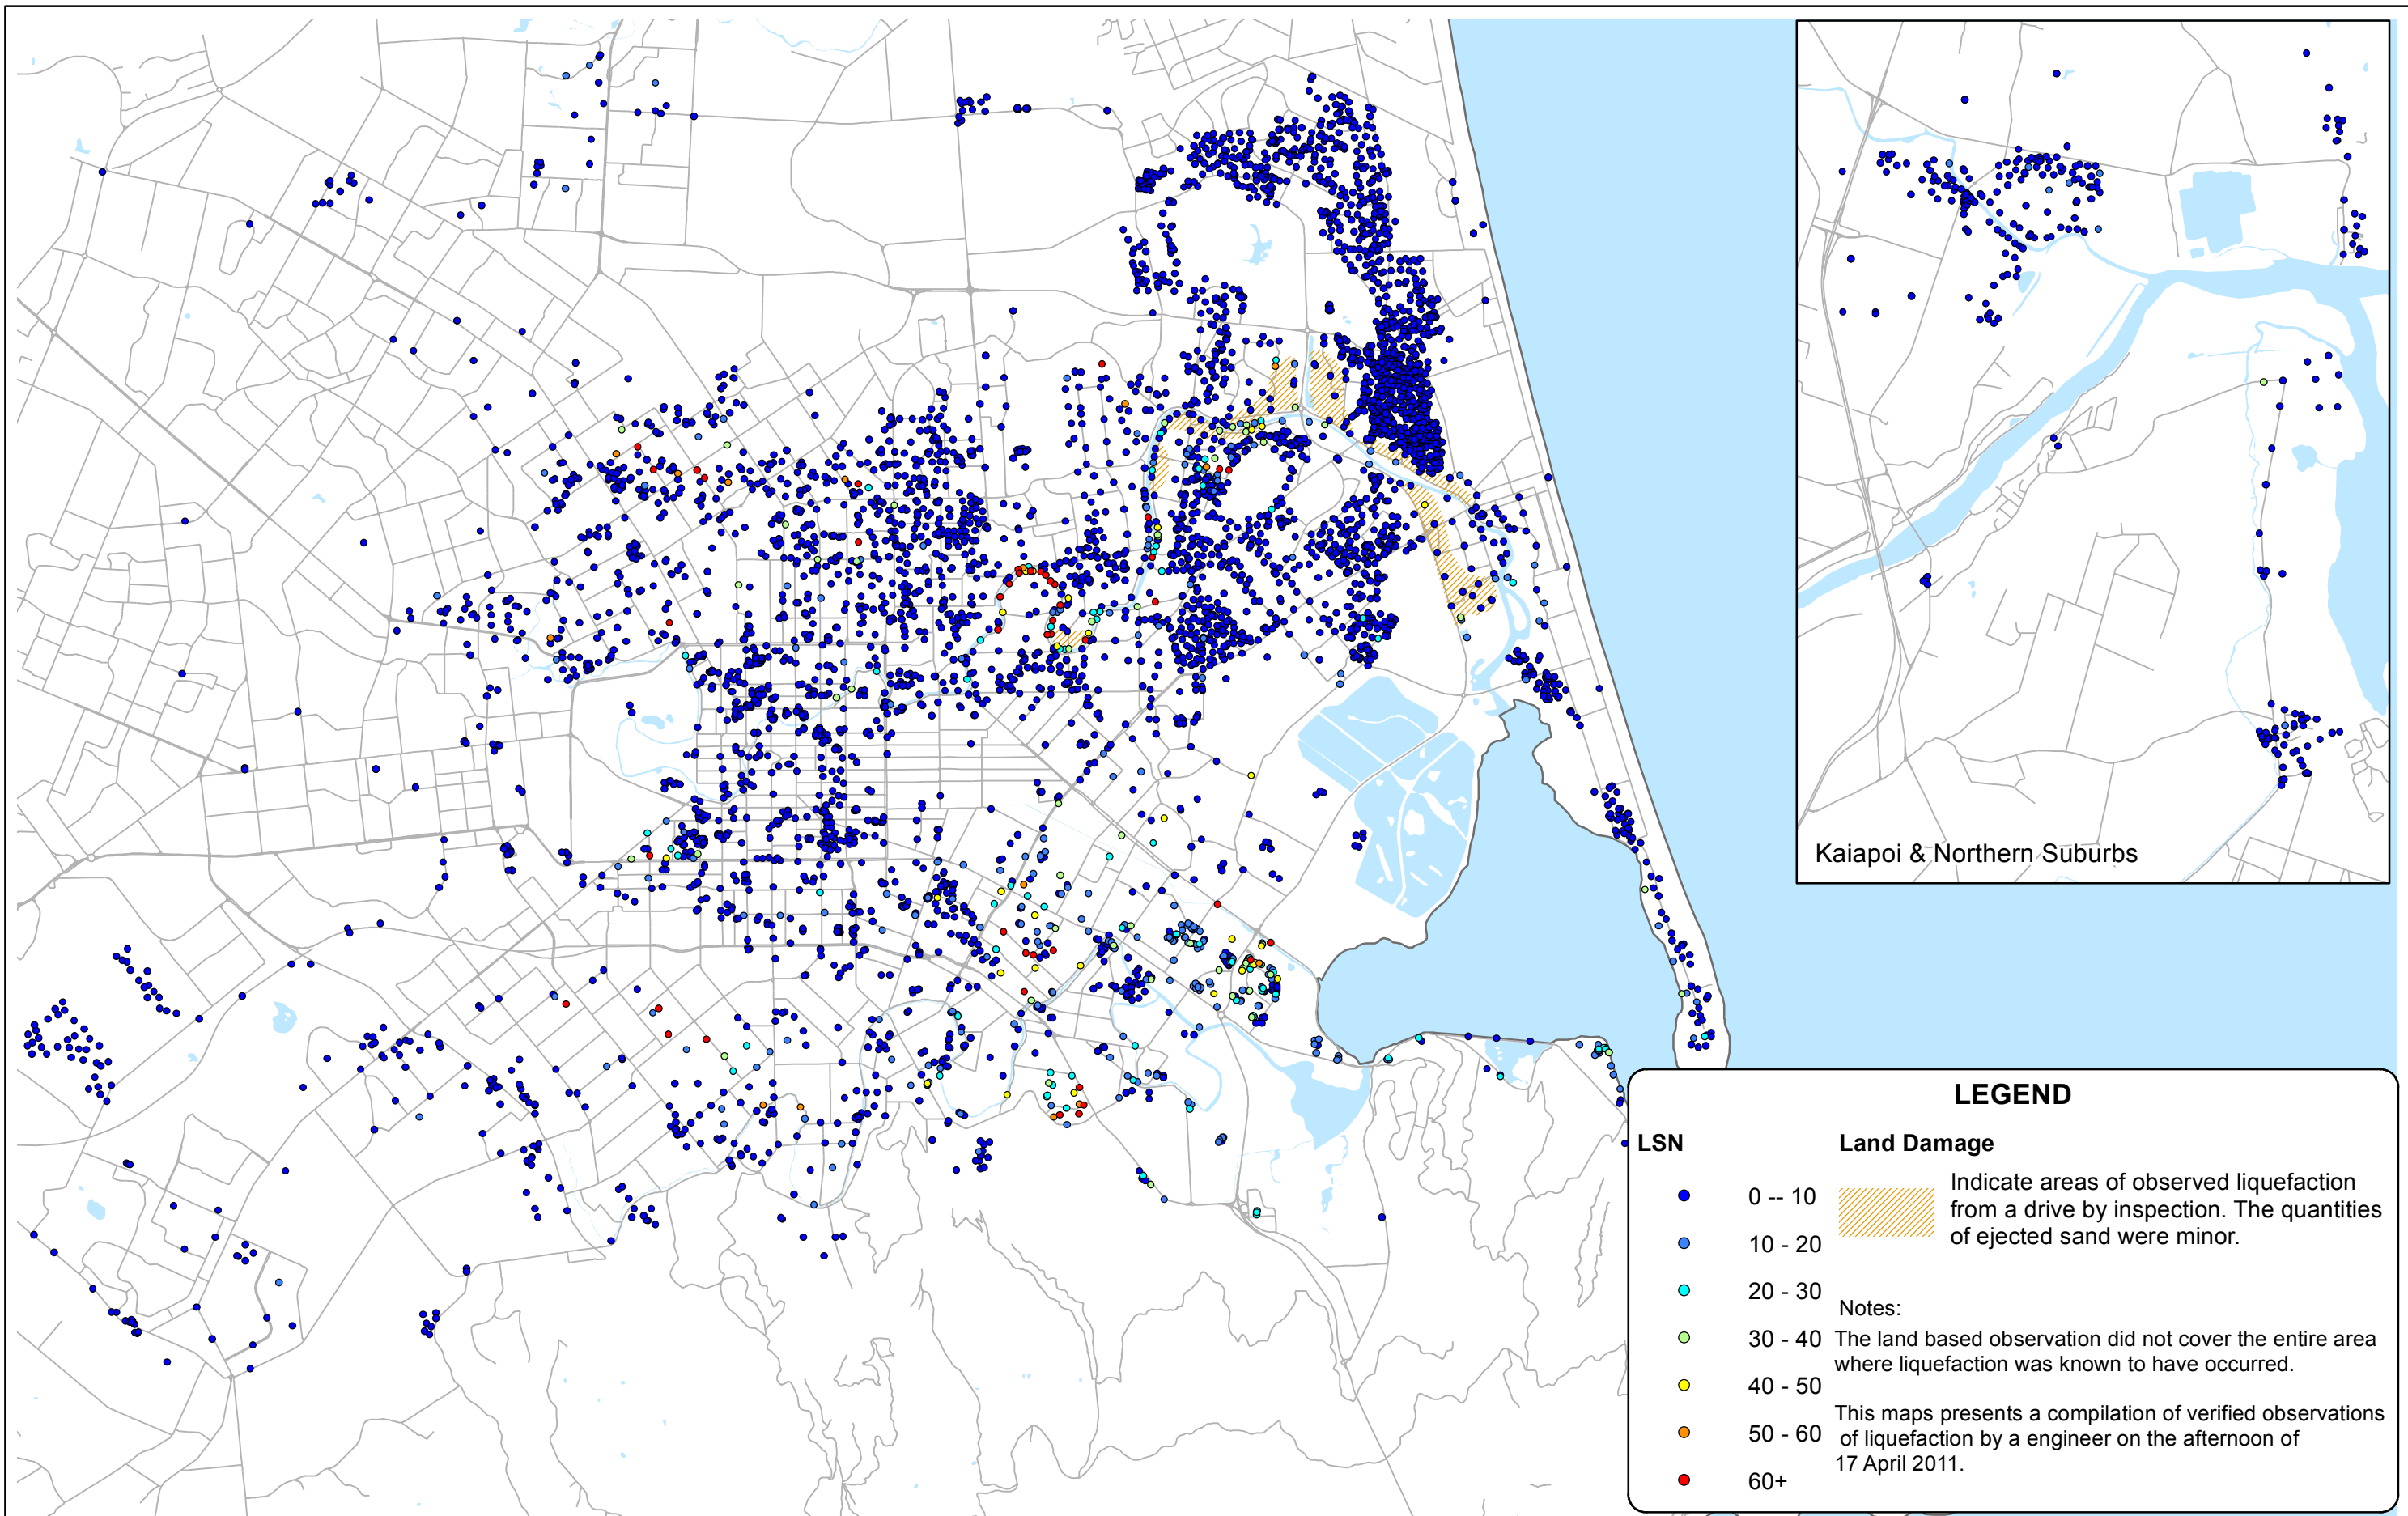
LSN		Land Damage
● 0 -- 10		Indicate areas of observed liquefaction from a drive by inspection. The quantities of ejected sand were minor.
● 10 - 20		
● 20 - 30		
● 30 - 40		Notes:
● 40 - 50		The land based observation did not cover the entire area where liquefaction was known to have occurred.
● 50 - 60		This maps presents a compilation of verified observations of liquefaction by an engineer on the afternoon of 17 April 2011.
● 60+
