| Prepared by Tonkin & Taylor Ltd. | | |

EARTHQUAKE COMMISSION  
CHRISTCHURCH CITY & KAIAPOI  
LPI, December 2011  
(Using Cornell PGA)

FIGURE No.  
Figure F53

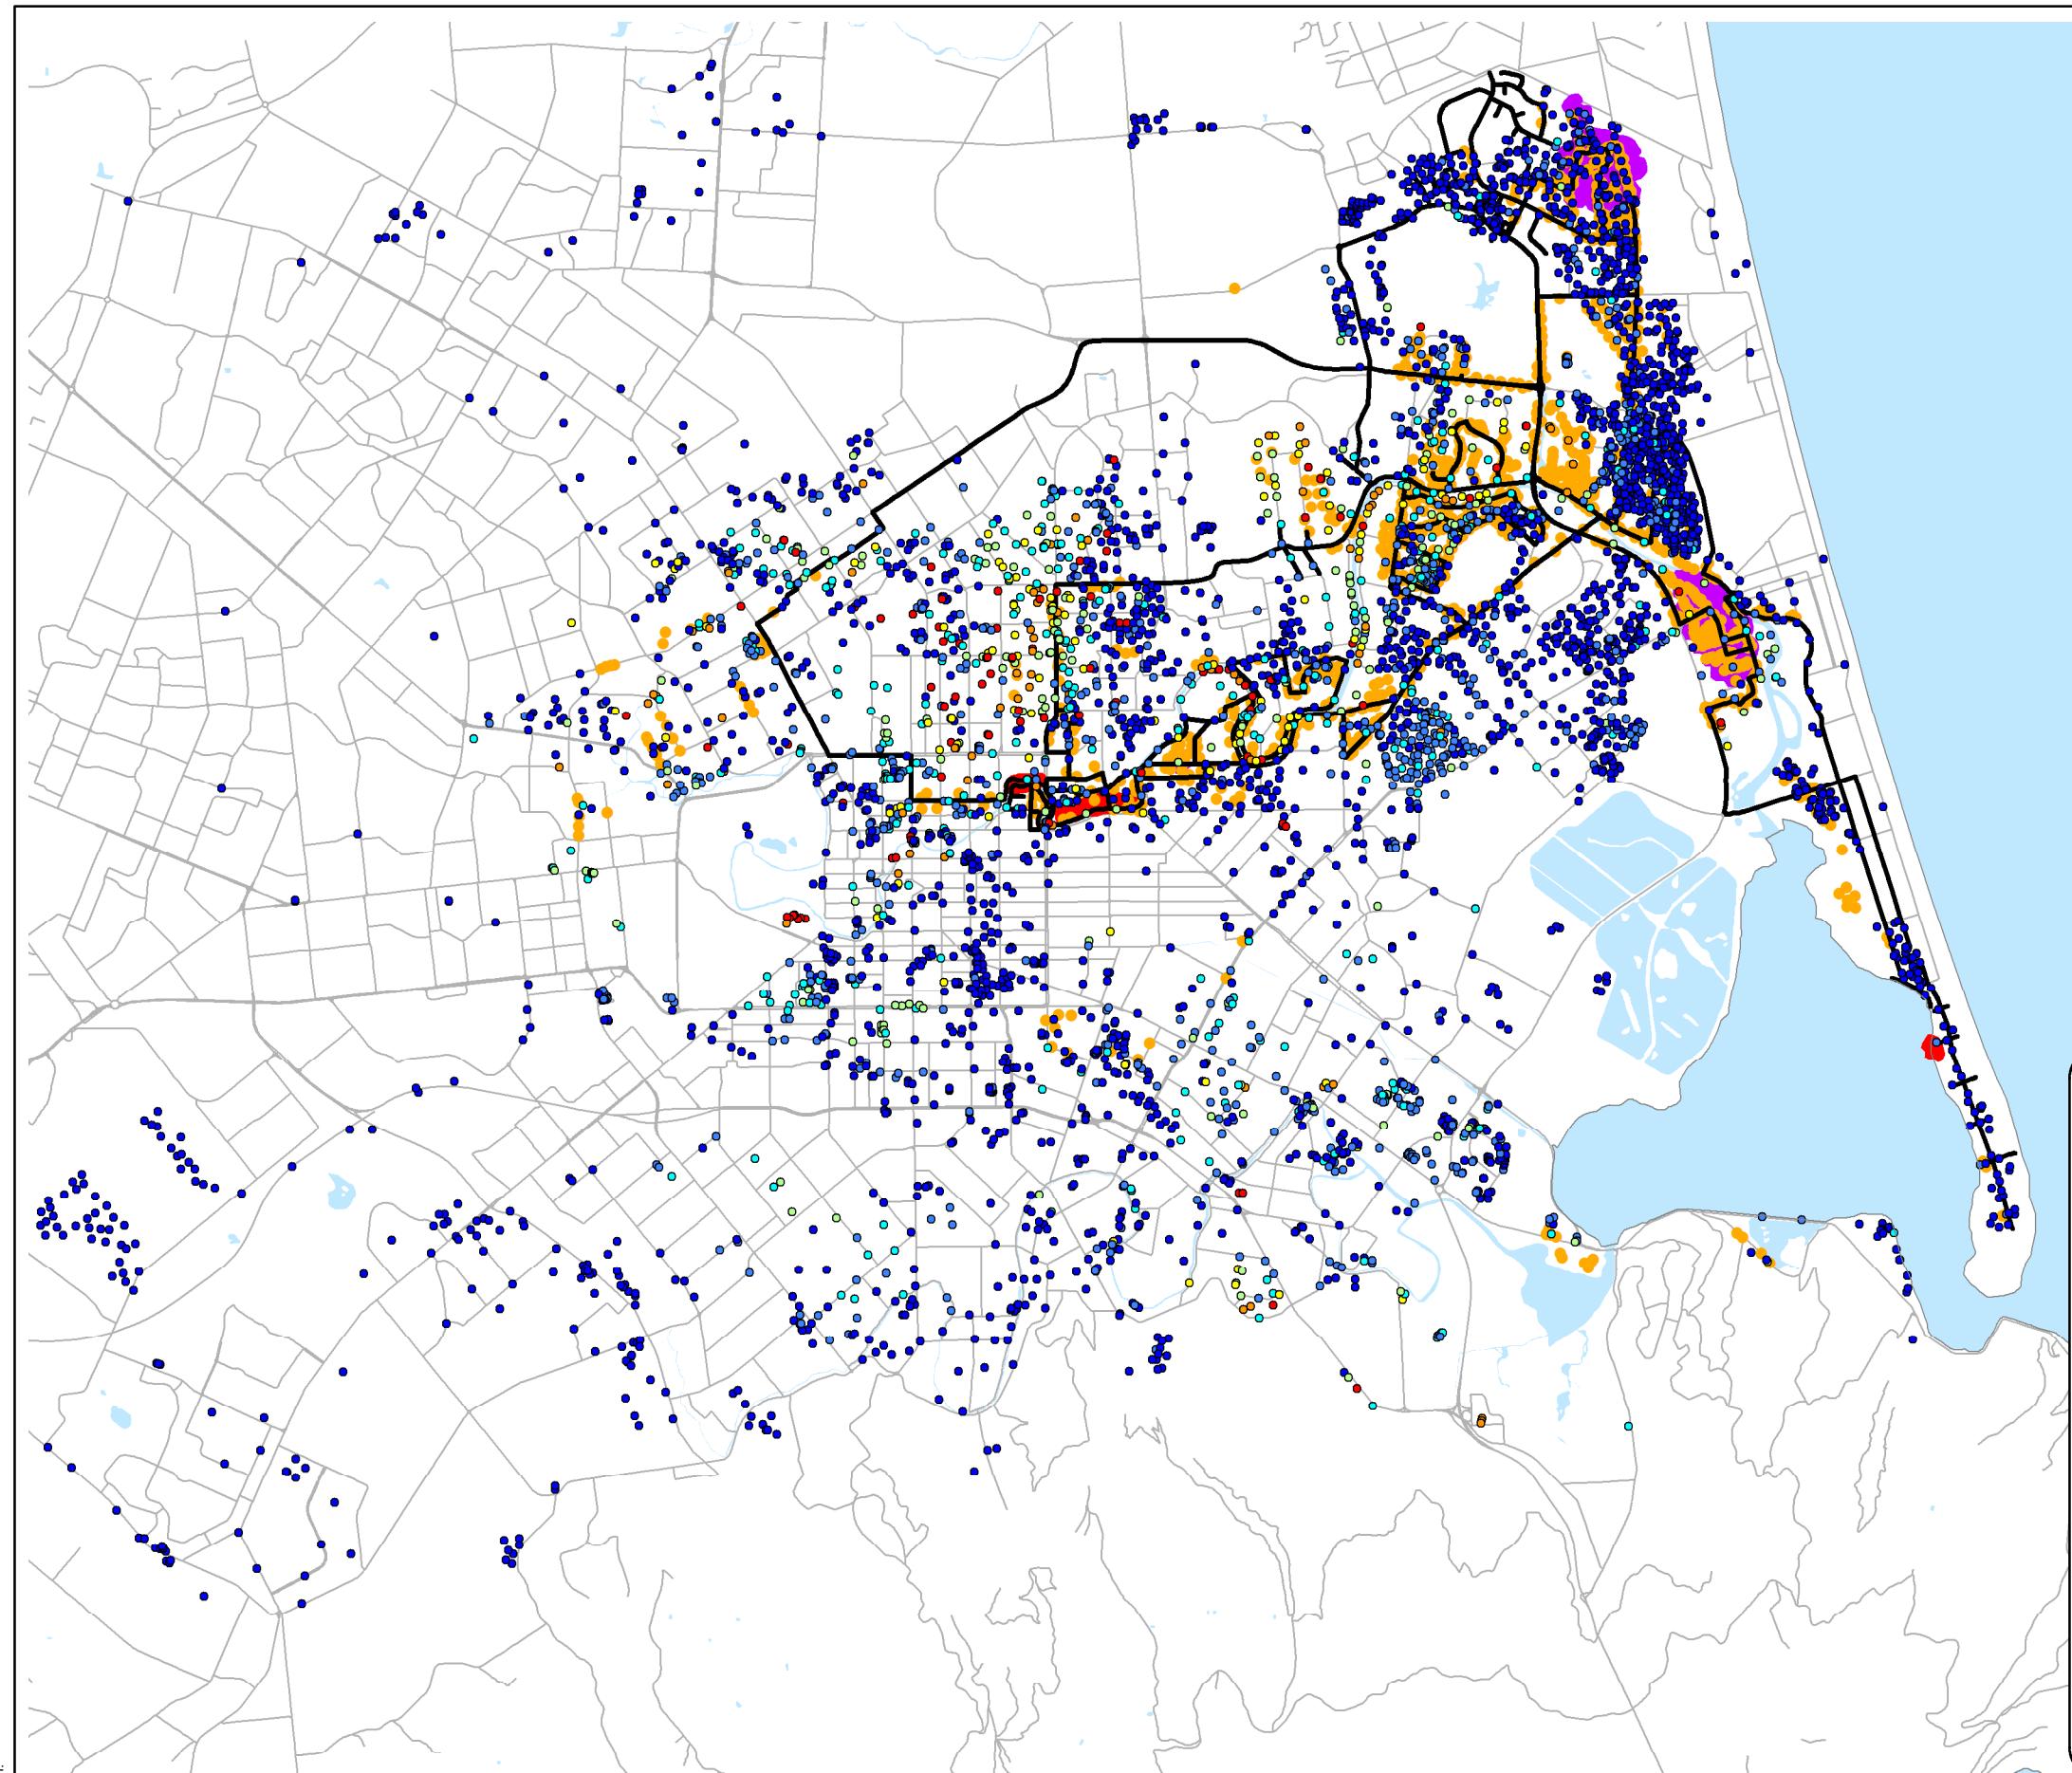
Notes:  
The land based observation did not cover the entire area where liquefaction was known to have occurred.

This map presents a compilation of verified observations of liquefaction by team of engineers on the afternoon of 23 Dec 2011.
